Manhole Inspection Summary

Manhole # S33WW_003MH

Insp Date: **6/7/07 11:58 PM**

Location Address: **3101 CHARLES ST**

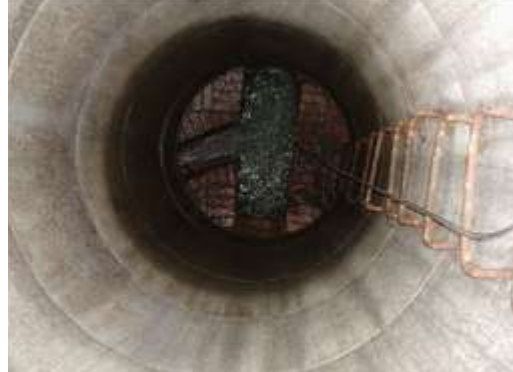
Top View

Barrel infiltration. Corroded steps.
Evidence of surcharge - Bench debris.

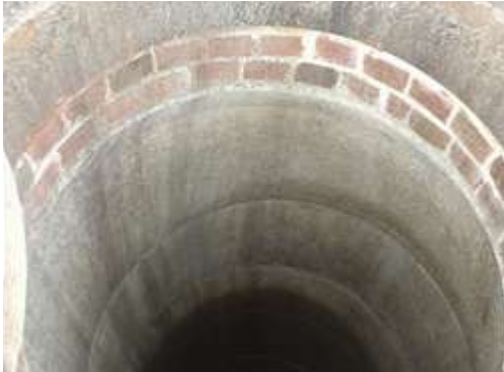
Defect

Frame leaks. Adjustment and Barrel infiltration.

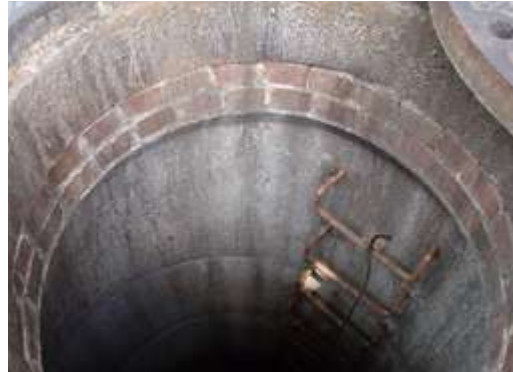
Defect

Frame leaks. Adjustment infiltration.

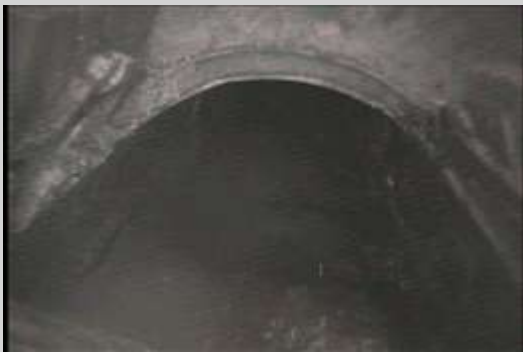
21 in. Circular Gravity Sewer Pipe Out @ 12 O'Clock

Infiltration: **Evidence** Pipe Seal Cond: **Unknown**
